**Old Parliament House, Adelaide –**

**The practicality of the Burra Charter process**

Andrew Klenke

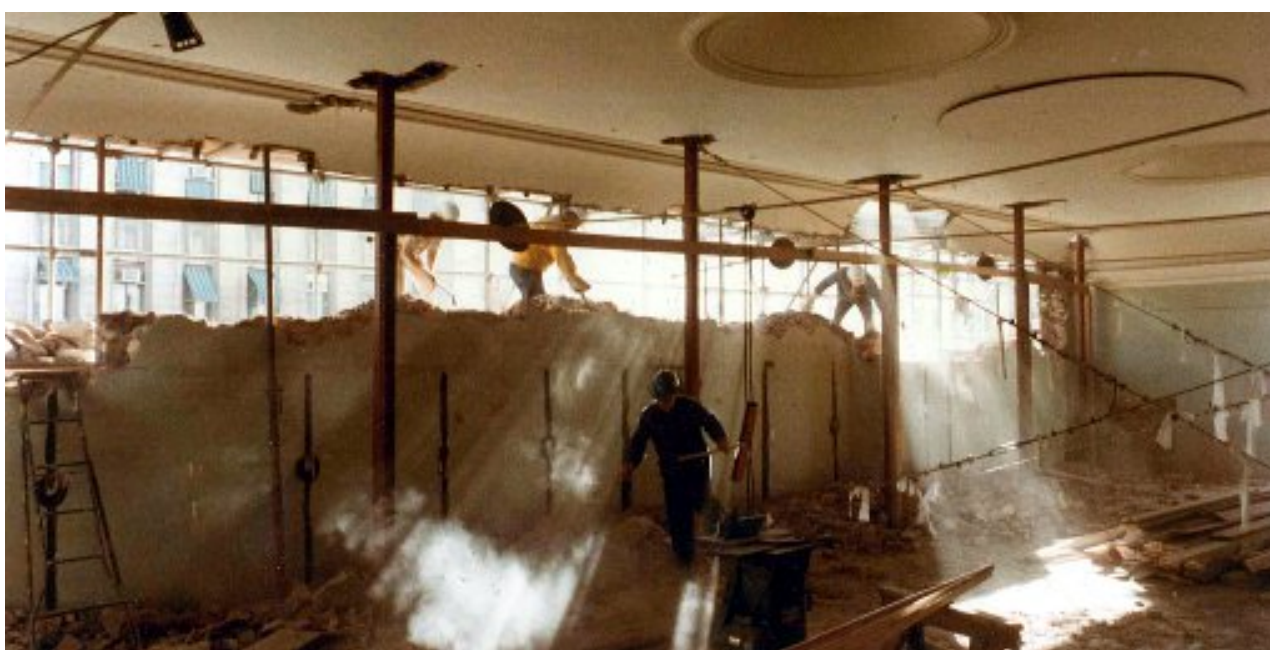
**Fig.3** – Demolition in progress on the upper west wall of the former Legislative Council Chamber c1978, showing the extent of intervention carried out at the time (*History SA*)

debated and won consent in 1894, while the first draft of the Federal Constitution was prepared here as part of the first Australian Federal Convention in 1897. With the eventual completion of Parliament House in 1939, Old Parliament House was then destined for demolition but was saved by the advent of World War II.<sup>6</sup> Post war shortages saw it used for various minor government purposes until its historical importance came to be acknowledged. It was subsequently conserved and reconstructed in the late 1970's to create a new museum of political history. This phase had not been researched previously. Of particular interest was a large collection of images which had been taken by the staff of the Constitutional Museum during the construction phase, these helping to confirm the nature and extent of some of those works and the degree of intervention which had taken place at the time (**Fig.3**).

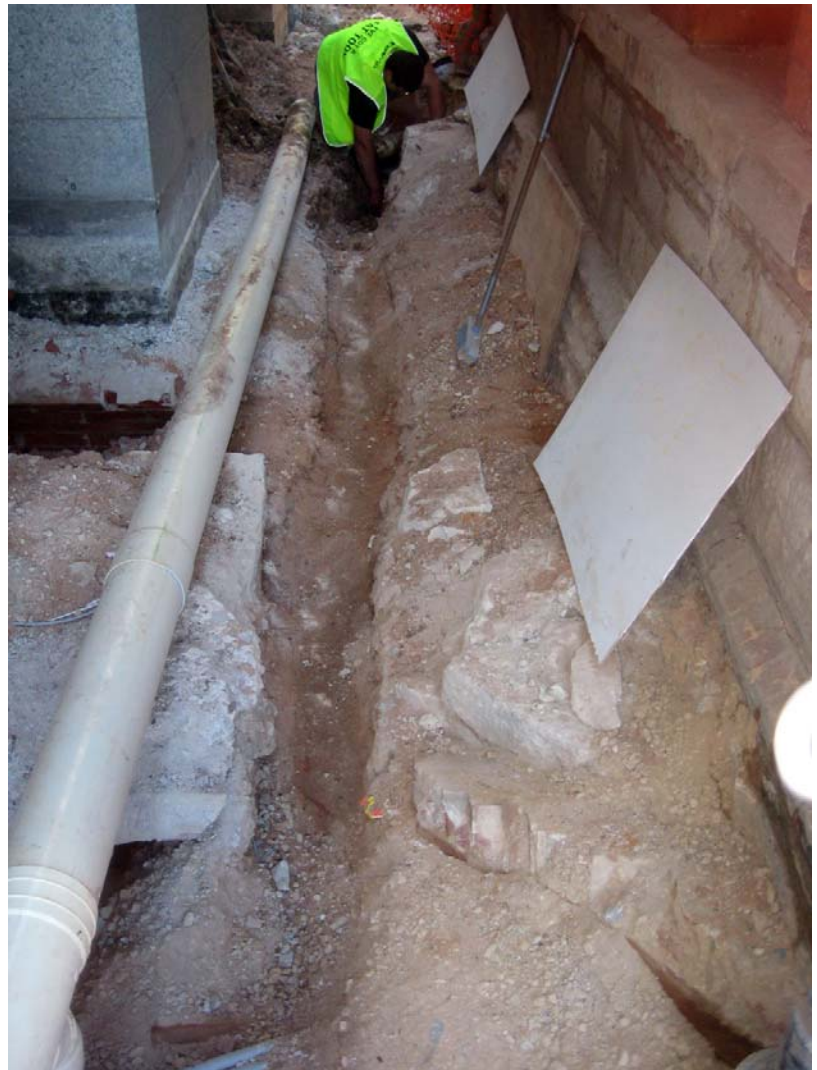
**Fig.4** – Service excavations revealed the footings of the former east bay window which required diversion of the services (Swanbury Penglase 2012)

removed in the early 1970s and the bay window to the east elevation removed in the 1880s for the construction of Parliament House (**Fig.4**). The discovery of these caused various services, including a major stormwater line, to be redirected to prevent further damage of those remains.

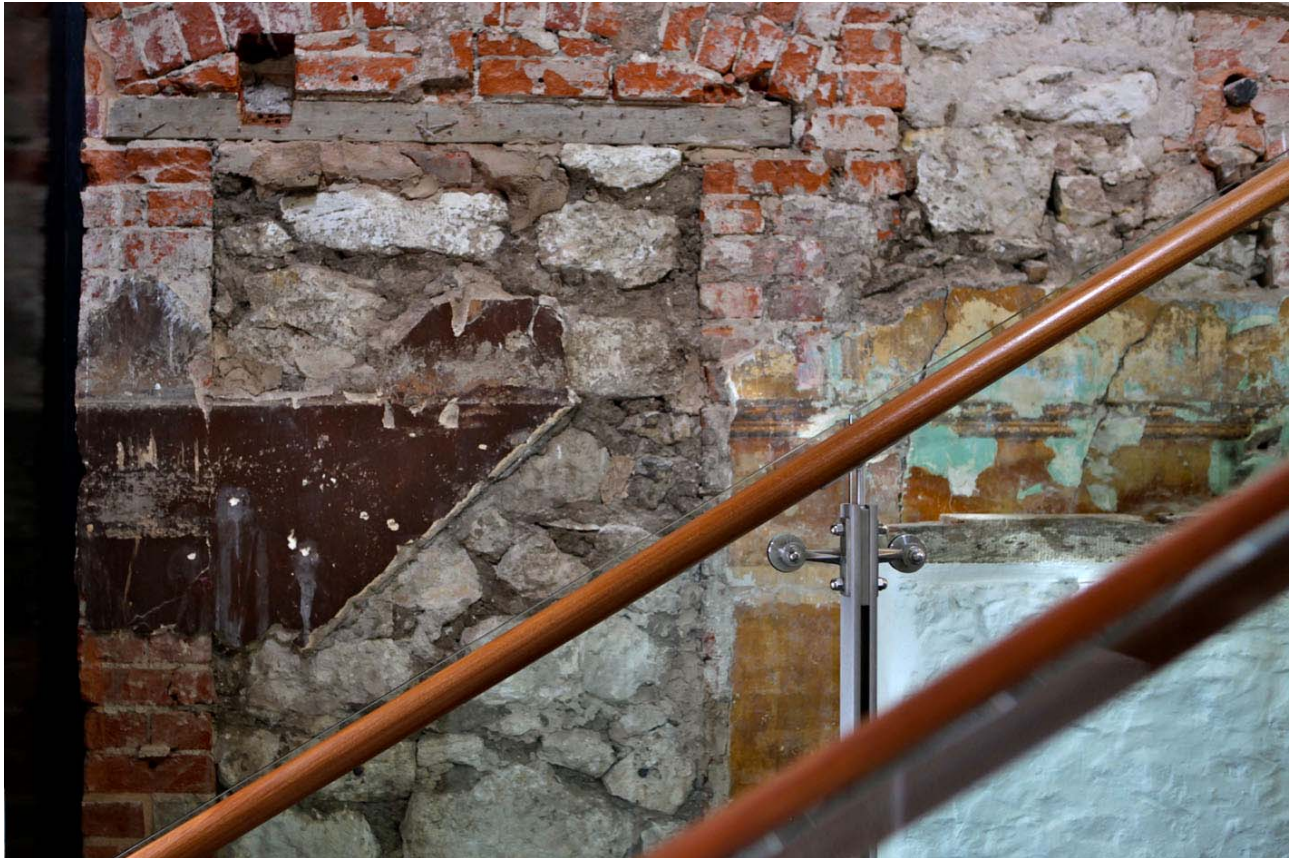
**Fig.6 –** Layering of fabric, both revealed and new, within the former Legislative Council Chamber (*David Russell 2014*)

The works did also reveal significant fabric that had previously been concealed. Some of this had been anticipated, such as the remains of the back of the 1843 building, but equally other fabric came as a surprise and helped to demonstrate the complex evolution of the building. This was particularly the case within the former plant room at the north end of the former Legislative Council Chamber. Here was a confusing but wonderful collection of fabric, including the base of the President's dais, as well as the remains of a series of French doors of what is thought to be the early 1850s Smoking Room, complete with its remnant wallpaper. These have been conserved and have been displayed for further interpretation (**Fig.6**). Remnant of a green paint colouring here also helped to inform a change of the paint colour within the former House of Assembly Chamber where no such evidence remained as a result of the works carried out there in the late 1970s.
